Maryland Historical Trust

Maryland State Highway Administration Maryland Historical Trust
SHA Bridge No. 16042 Name: MD 212 over Northwest Branch (Northwest Branch Bridge)
Location: Street/Road Name and Number: MD 212 (Riggs Road)
City/Town: Takoma Park Vicinity X
County: Prince George's
Ownership: X State County Municipal Other
This bridge projects over:RoadRailway_X_WaterLand
Is the bridge located within a designated district: yes X no
_NR listed district_NR determined eligible district _locally designated_other Name of District
Bridge Type:
_Timber Bridge _Beam Bridge_Truss-Covered_Trestle _Timber-and-Concrete
_Stone Arch
_Metal Truss
_Movable BridgeSwingBascule Single Leaf_Bascule Multiple LeafVertical Lift_Retractile_Pontoon
Metal GirderRolled Girder Concrete EncasedPlate GirderPlate Girder Concrete Encased
_Metal Suspension
_Metal Arch
_Metal Cantilever
X Concrete X Concrete Arch _Concrete Slab_Concrete Beam Rigid Frame
_Other Type Name

PG: 65-22

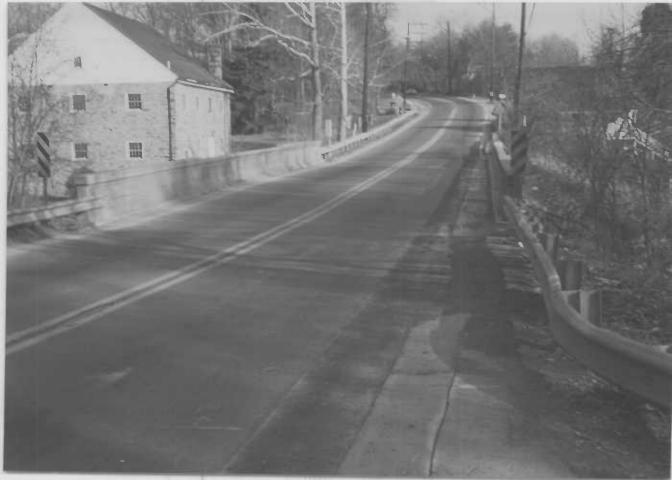
Name 16042- MD 212 OVER NORTHWEST BRANCH County/State YRINCE GEORGES COUNTY/MO Name of Photographer WALLY KING Date 195
Location of Negative SHA
Description SOUTH APPROACH WUKING NURTH
Number Kof X

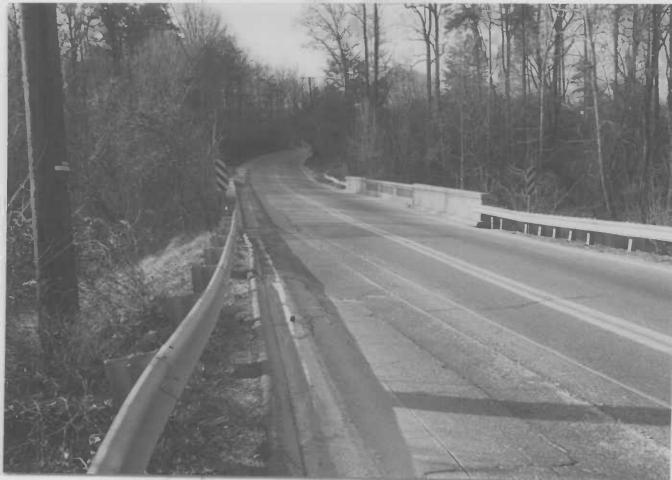
Name 1614 County/State Name of Pho Date 16	otographer	E GEURC	ES C	DIAHV	ANCH
Location of	Negative	SHA			
Description	NORTH	APPROP	JCH	LOOK	ING
Number 2	6

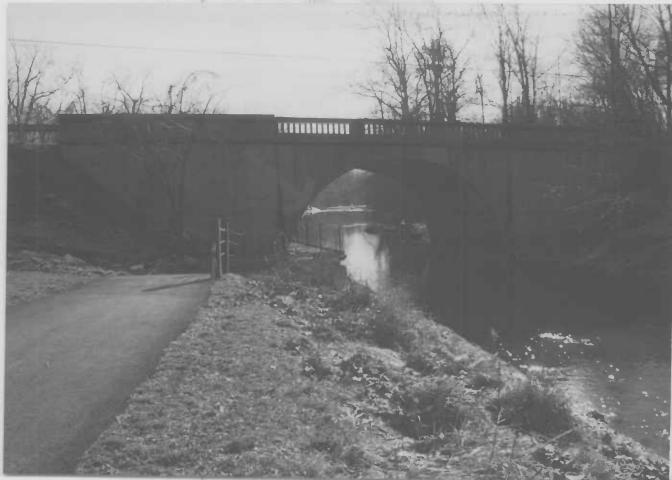
Name 16042 - MO 212 OVER NORTHWEST BRANCH
County/State PRINCE GEORGES COUNTY/MO
Name of Photographer WALLY KING
Date 1 95
Location of Negative SHA
Description WEST ELEVATION
Number 22 of 24

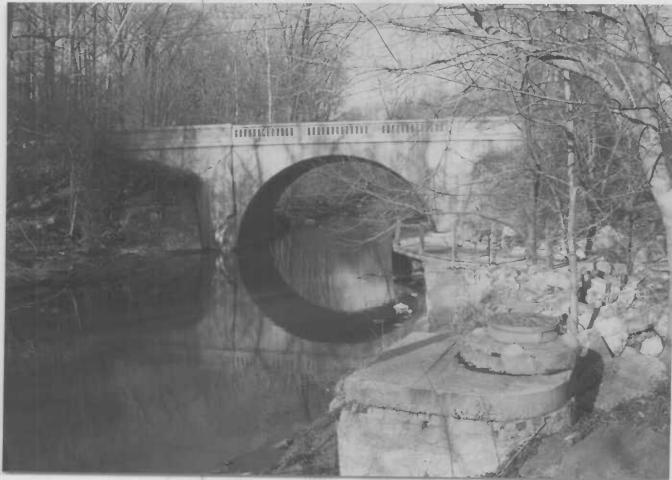
Name 16042-MD 212 01	VER NORTHWEST BRAN	14
County/State PRINCE	GEORGES COUNTY "	10
Name of Photographer 1	WALLY KING	
Date 1195		
Location of Negative	SHA	
Description EAST E	ELEVATION	
5. 6.		
Number 23 of 2

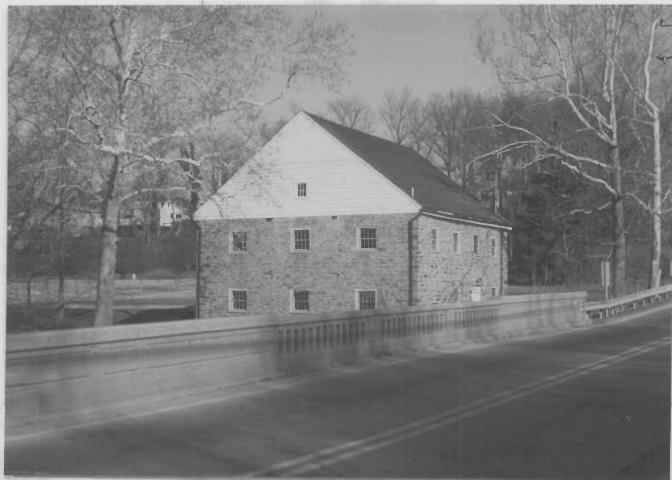
Name 16042-MD 212 WER NORTHWEST BRANCOUNTY/State PRINCE GEORGES COUNTY/M Name of Photographer WALLY KING Date 195
Location of Negative SHA
Description ADELPHI MILL - 1811
Number 24 of 24
